Home Inspection Report

555 Wind Way, Fake City , OR 54645

Inspection Date:

Monday May 12, 2014

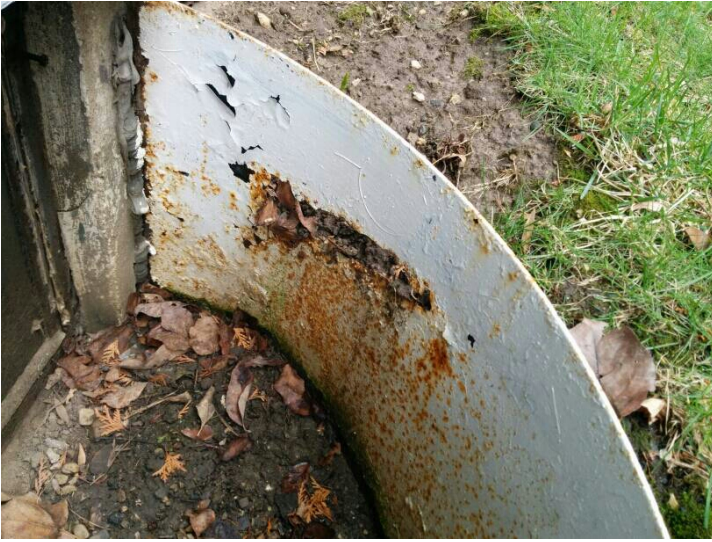
Negative Grade ☒ West ☒ North ☒ Recommend window wells/covers
Comments Metal window wells were rusted recommend repairing/replacing as needed

Rusting of window wells repair/replace as needed

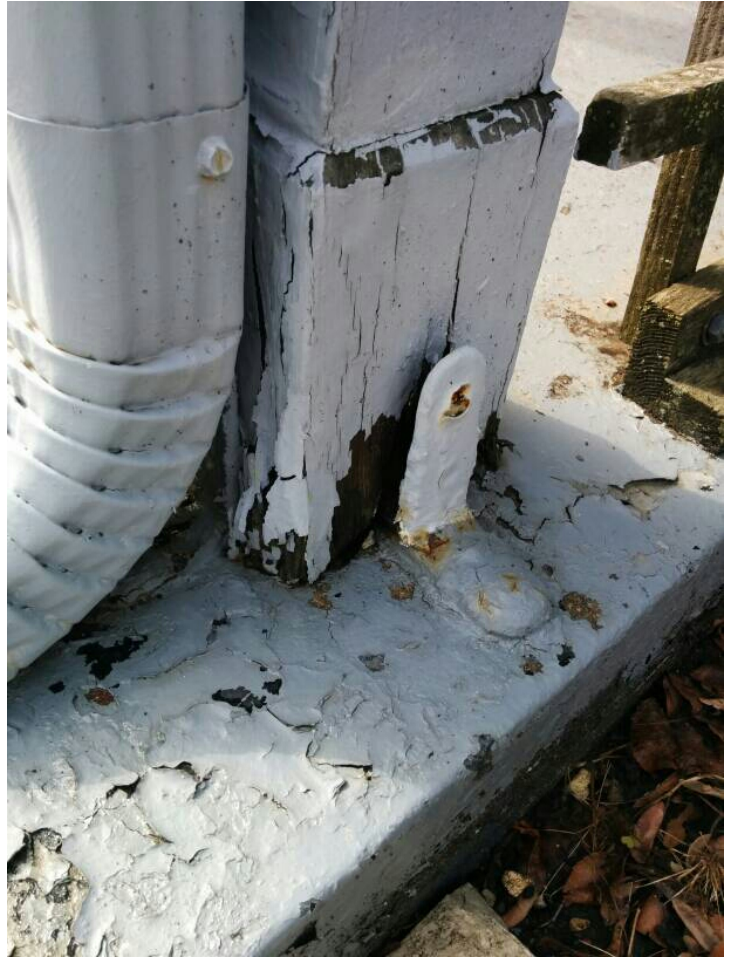
Condition ☒ Marginal
Support Pier ☒ Wood
Floor ☒ Satisfactory
Comments Porch posts had some damaged wood and was in need of repair and/or replacement. Support pier is not properly supported, repair as necessary.

Wood rot on support pier on front porch recommend replacing damaged wood.

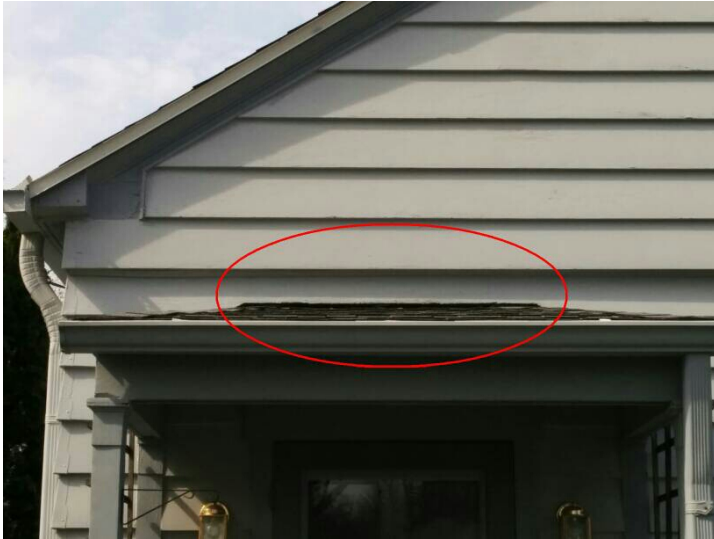
Flashings are not visible around chimney covered with roofing cement so not visible recommend monitoring for leaks. Recommend flashing above front porch where wall meets roof to prevent any water penetration into home.

Missing wall to roof flashing recommend installing one to prevent water penetration into home.

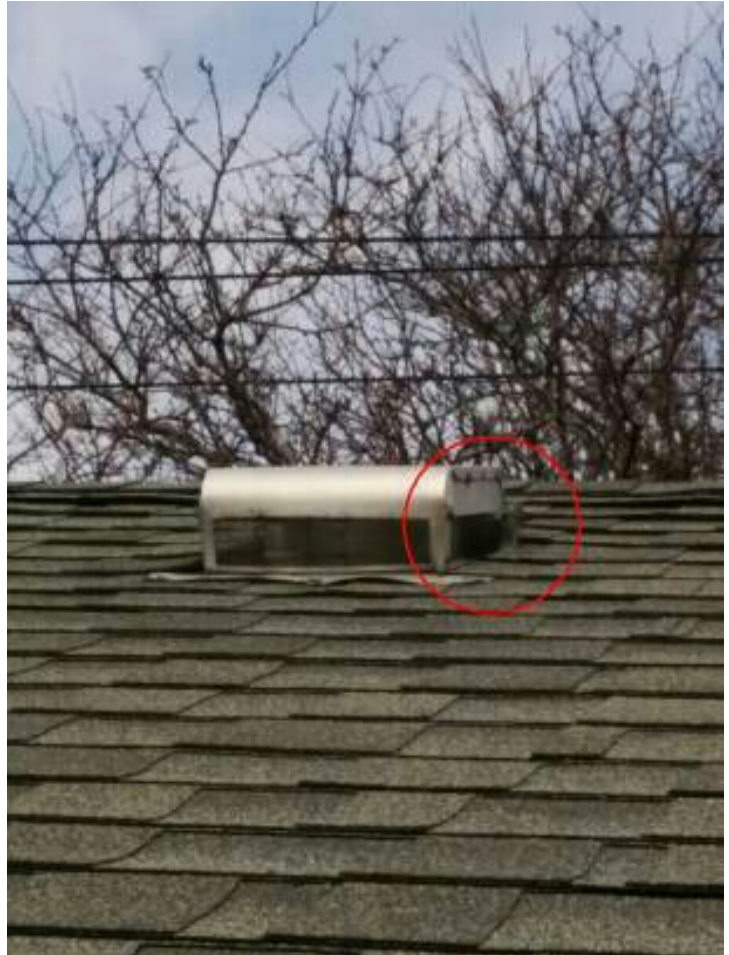
Damaged screen on roof vent recommend replacing screen to prevent pests from entering attic

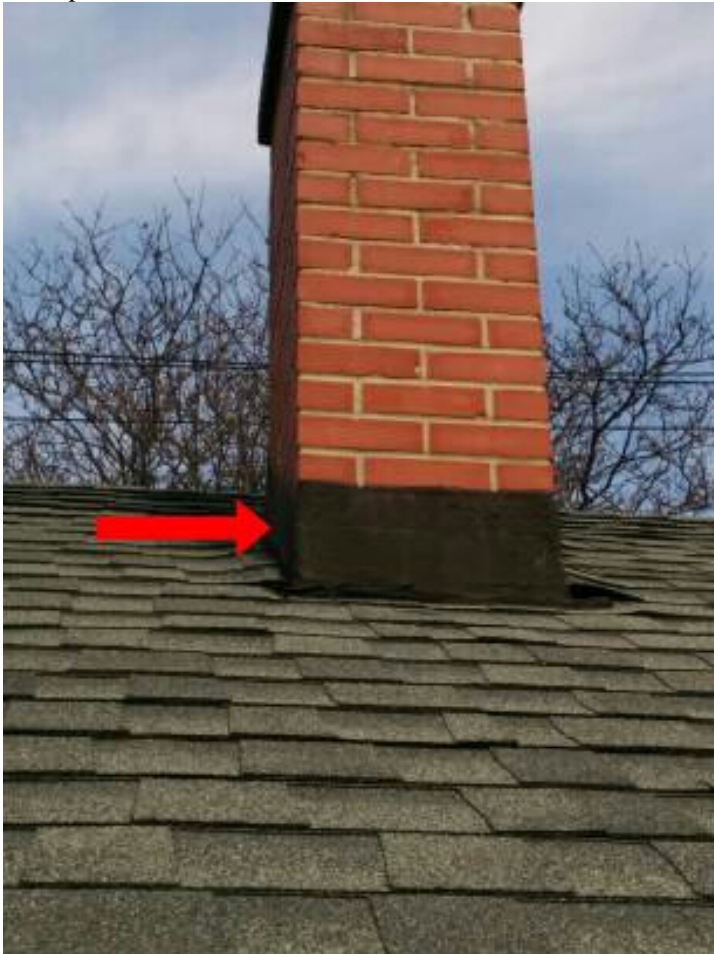
Chimney flashing covered with roofing cement not visible.

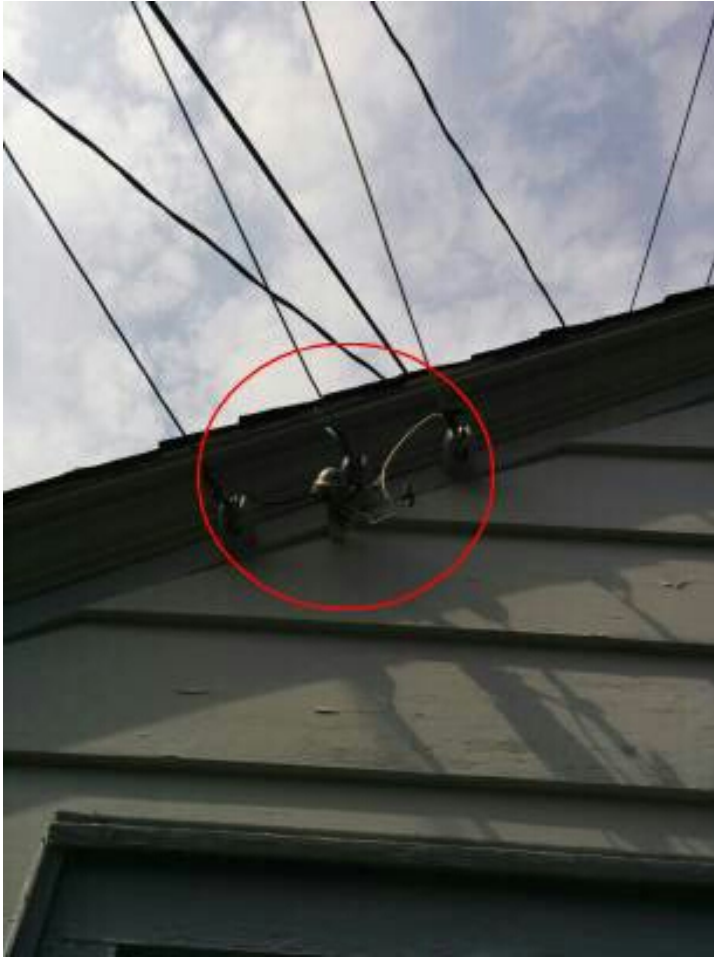
Comments Exposed wires running from home to garage recommend repair by a qualified electrician potential safety hazard.
Could not verify if light on northside of exterior of home worked.

Exposed wires recommend repair by a qualified electrician.

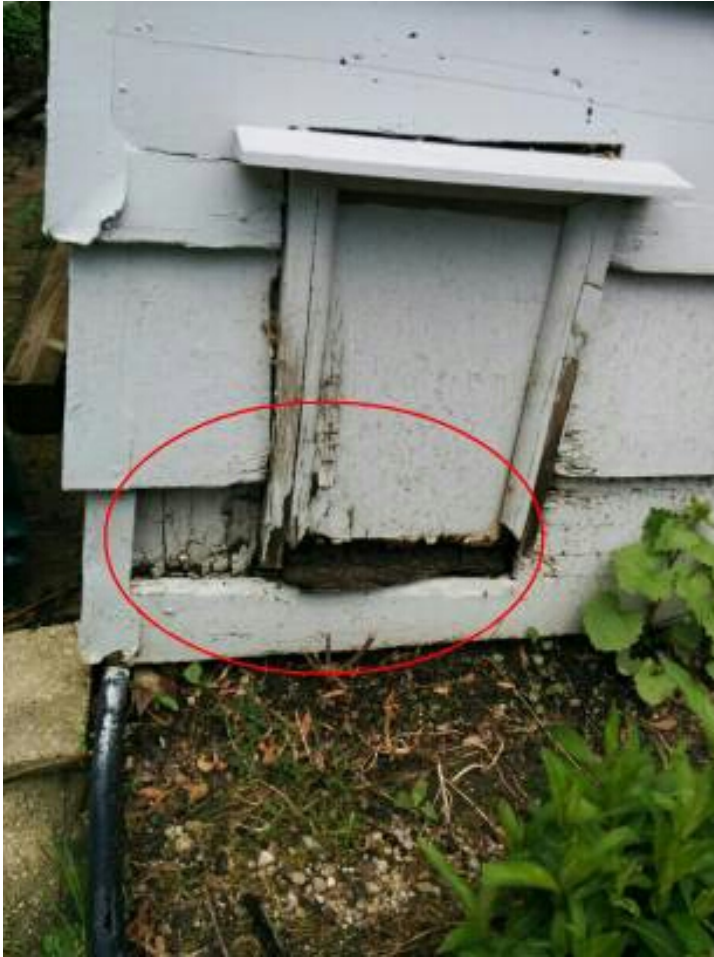
Comments Siding had some damage and was in need of repairs. Recommend trimming trees and keeping soil 6-8" away from siding

Areas of siding on garage are damaged recommend repair/replacing damaged areas as needed.

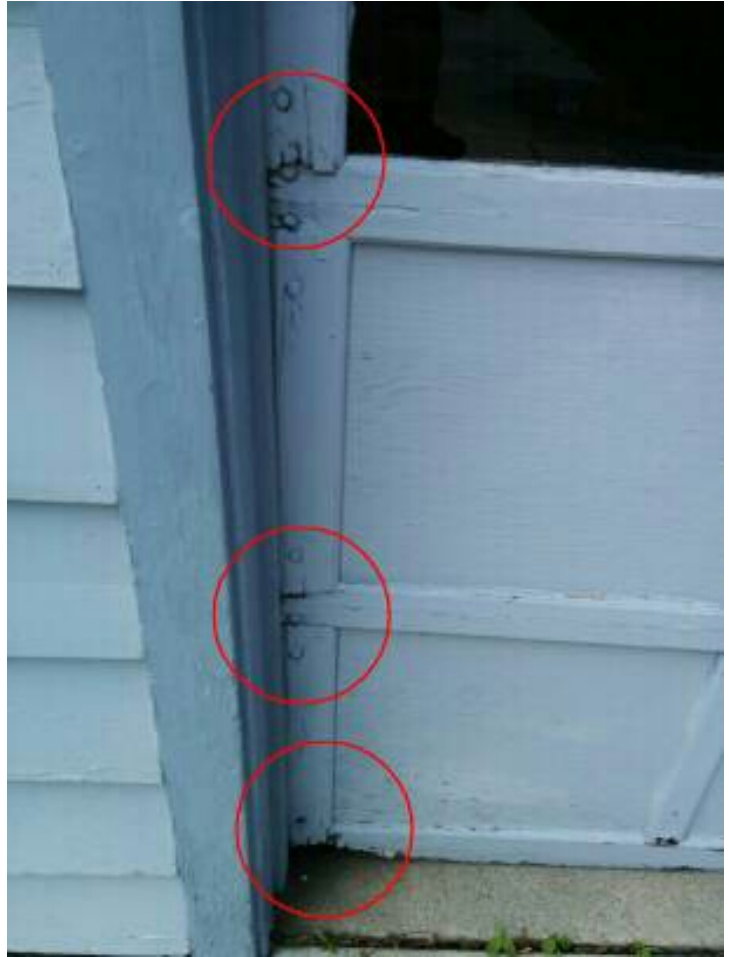
Comments Garage door was damaged and in poor condition recommend repair / replacement.

Overhead door damaged recommend repair/replacement

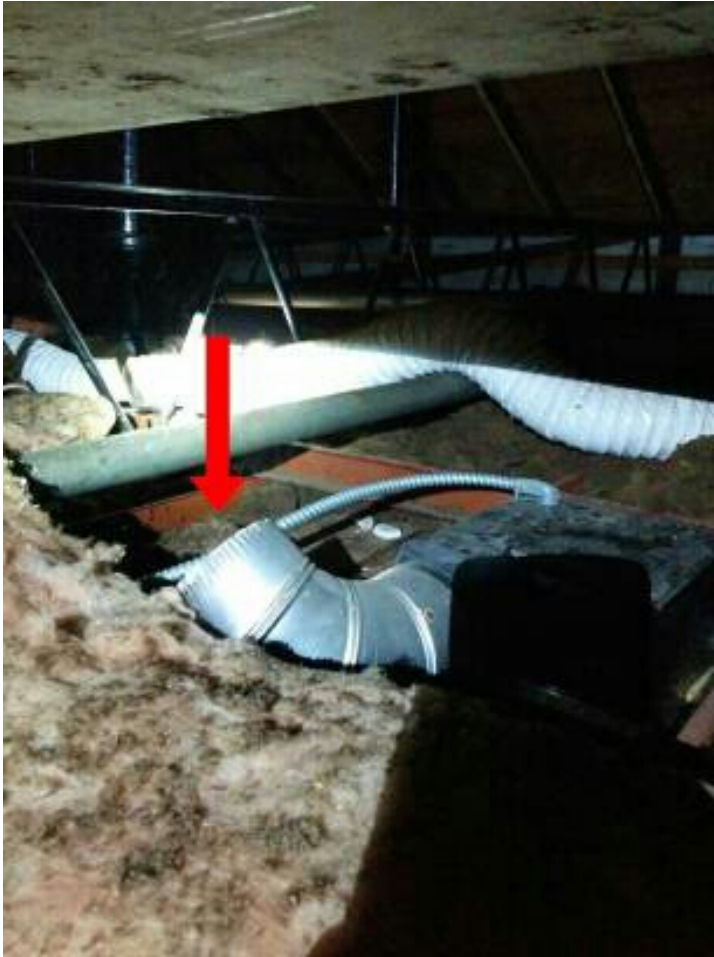
Recommend exhausting to exterior

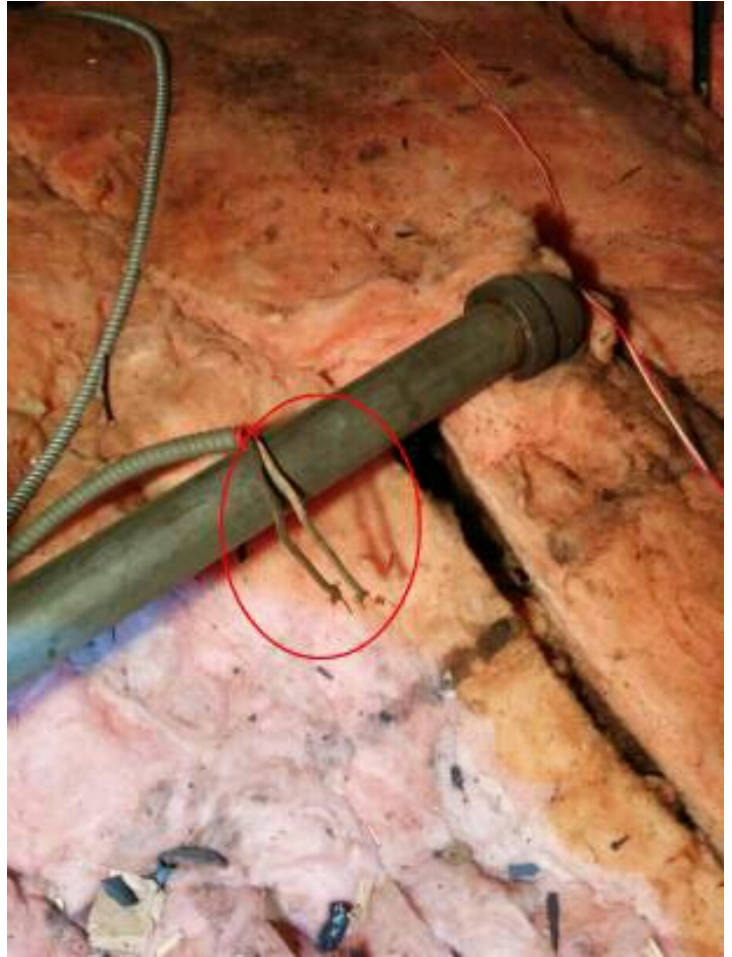
Comments Recommend properly venting bathroom and kitchen exhaust to exterior. Exposed wires recommend a qualified electrician properly terminate in junction box. Old stains on wood no apparent leaking at time of inspection.

Exposed wires recommend terminating in junction box
